## Report of an investigation into an accident involving the fishing vessel Bikain at Dingle, Co. Kerry, Ireland 25 November 2022

**REPORT OF AN INVESTIGATION  
INTO AN INCIDENT INVOLVING THE  
FISHING VESSEL BIKAIN  
AT DINGLE, CO. KERRY,  
IRELAND  
25 NOVEMBER 2022**

**REPORT NO. MCIB/323  
(No.6 OF 2023)**

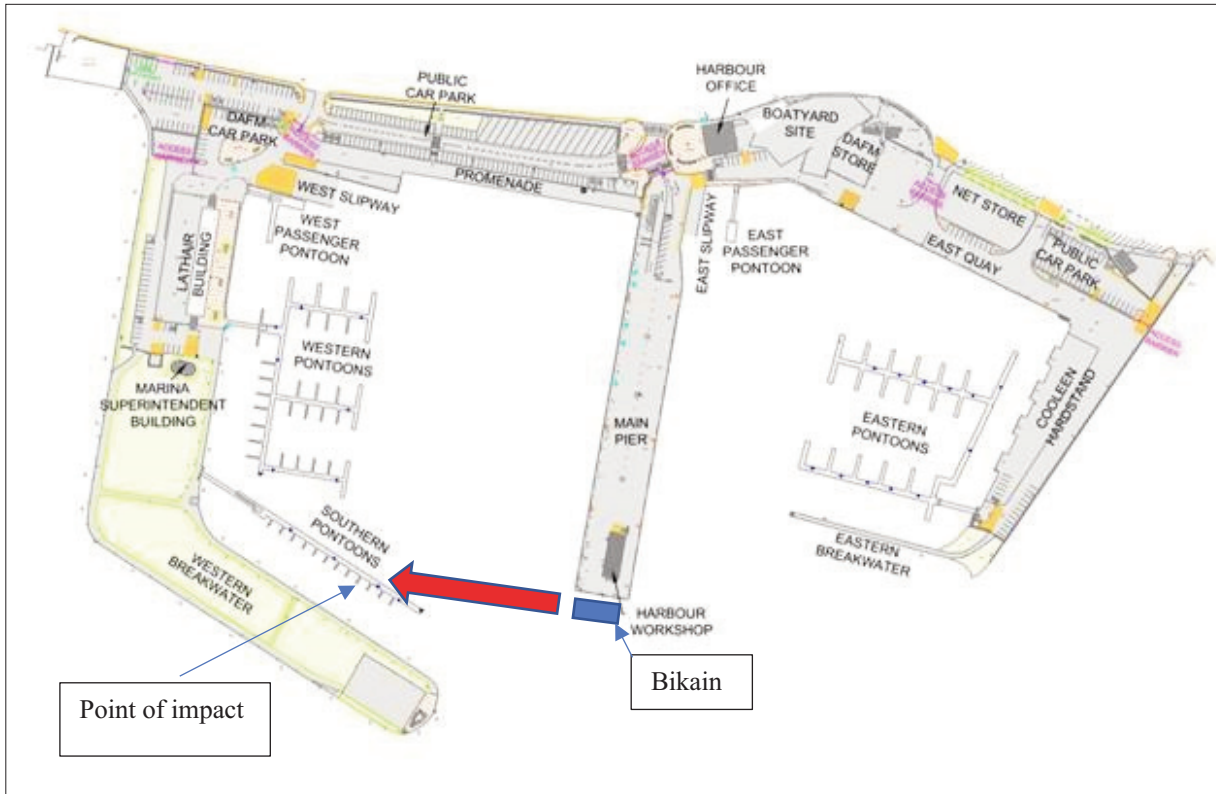
Dingle Harbour showing Location of FV Bikain at the Main Pier and Impact Point on Southern Pontoons.

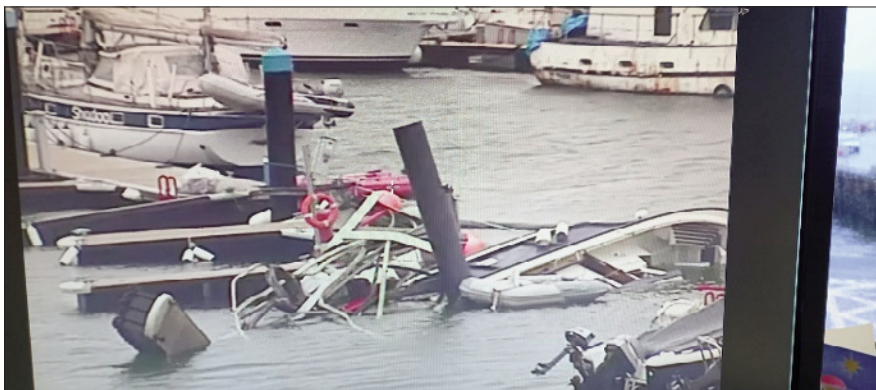
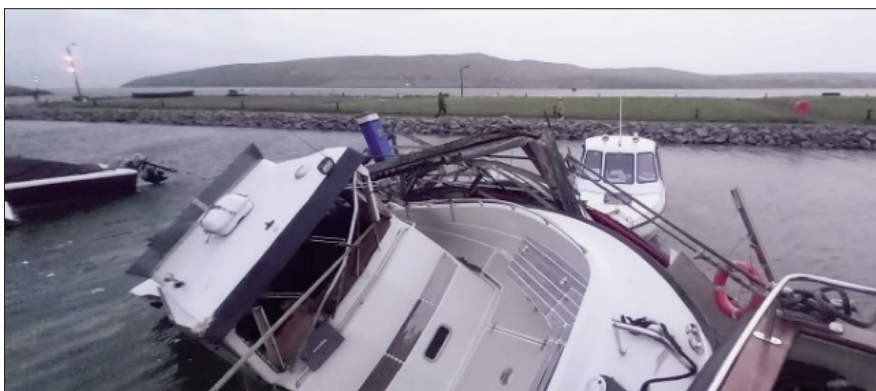
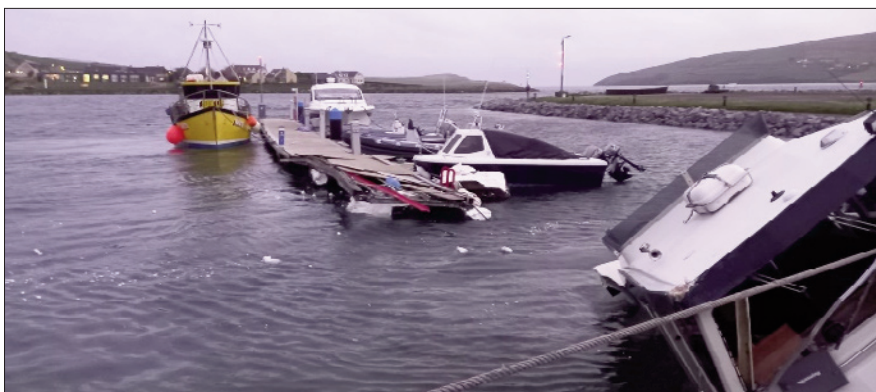
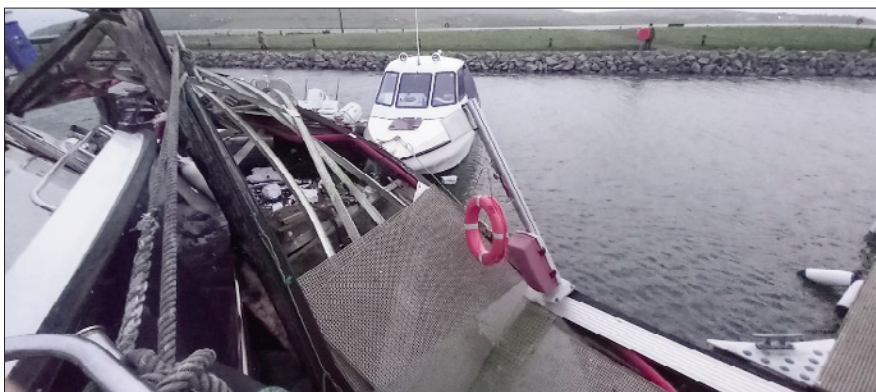
Appendix 7.2 Photographs of Damages caused to Boats and Pontoons

Consequences: Heavy impact with the southern boat pontoons causing serious damages to the pontoons and the support piles and serious damages to boats moored on the pontoons at the time.

- 3.10 While the Chief Engineer was attempting to stop the engine, all the mooring ropes had parted. The vessel moved quickly astern and made heavy contact with the southern pontoon and the boats that were moored there. This pontoon was approximately 110 m from the original moored position of the FV Bikain.

- 3.11 The engine was still running when the vessel hit the pontoons and the vessel was being pushed hard into the pontoons and associated boats. When the engine finally stopped the vessel drifted out from the pontoons and into the harbour basin. The vessel was without propulsion power at this time.

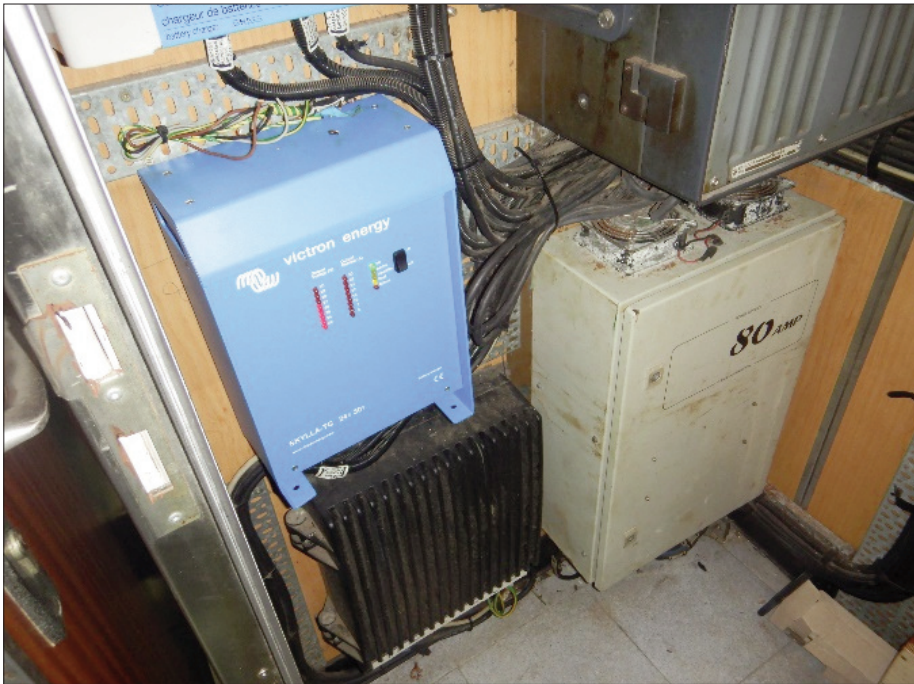
time of this incident there was a temporary charger fitted in place of the failed unit. This temporary charger had now failed.

- 3.21.2 Two new battery charges had been fitted in the electrical locker and had been working well without incident since installation.
  - 3.21.3 A new solenoid had been fitted on the gearbox for the propeller pitch control unit that would hold the pitch in neutral position in case of power failure and this solenoid could also be manually actuated to control the pitch of the propeller.

4.3.8 The battery charger had failed in service, and a temporary charger had been fitted to keep the vessel operational, but the reason for the failure of the charger was not properly evaluated. The charger was actually being used as a power supply and running at high loads most of the time when the vessel was in operation and these chargers have limited lifespan when operated in this manner.

New Battery Charger.

- 3.19 A new battery charger was supplied and fitted, and after appropriate testing, the vessel resumed normal operations.
- 3.20 The FV Bikain completed two further fishing trips after the incident without experiencing any difficulties and then proceeded to Spain on 2 December 2022 for repairs and to complete Classification surveys for Bureau Veritas to take the vessel into Class. The vessel was in Spain from 19 December 2022 to 12 January 2023 when she returned to the same fishing grounds off the west coast of Ireland.

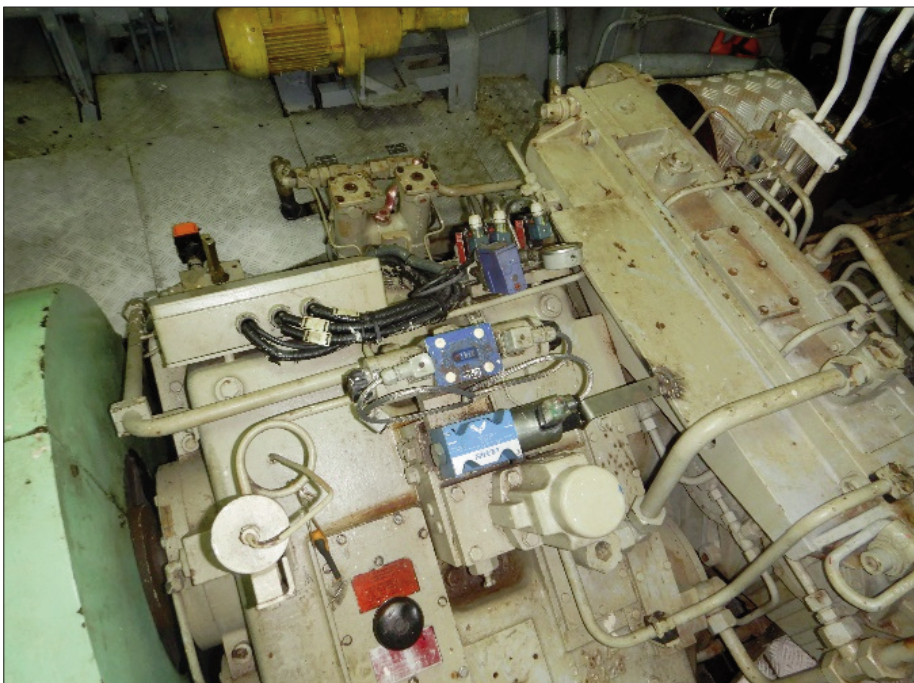
4.5.1 The default failure position of the CPP in event of power failure was full astern and this was the position the propeller assumed during the casualty. This position is attained when the hydraulic oil pressure is lost and a spring in the CPP system pushes the propeller pitch control rod to the full astern position. There was no manual override or method to control the pitch in such a failure condition. This was a contributing factor in this casualty.

New Solenoid for CPP (blue unit on top).

4.5.2 After this failure the owners had the system modified by fitting a new solenoid in the CPP hydraulic control system and this solenoid will now default to neutral pitch on a power failure. This solenoid also has manual control spindles that will allow the pitch to be controlled ahead or astern without power on the system.
