**REPORT OF AN INVESTIGATION  
INTO A MARINE CASUALTY  
INVOLVING THE FISHING VESSEL  
ARDENT  
EAST OF PORT ORIEL,  
CLOGHERHEAD, CO. LOUTH  
31 OCTOBER 2022**

**REPORT NO. MCIB/320  
(No.2 OF 2024)**

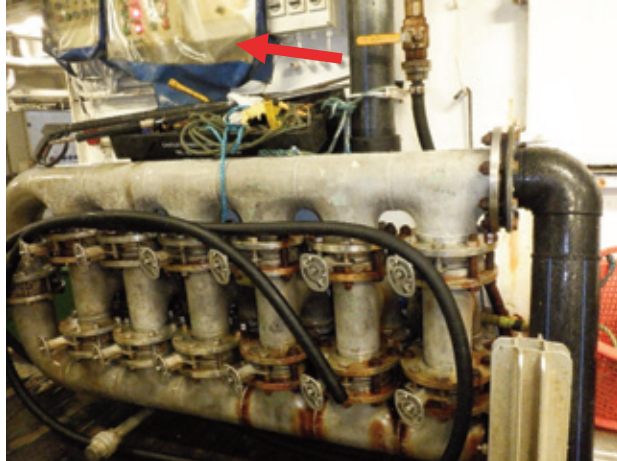
Picture No.1 Valve Chest

The outboard tanks were first to be cleaned with the Skipper opening the required valves (Picture No.1) and operated the pump to flush water into the tanks. The flushing requires the pumping of water to the upper and then lower diffuser while discharging the water via a bilge pump fitted in the engine compartment but operated via the deck panel (red arrow Picture No.1).

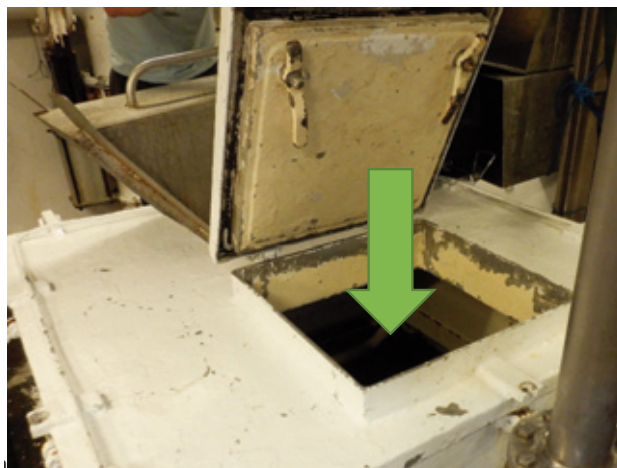
Picture No.2 Centre Tank Access Hatch

- 3.3.2 Noticing a number of fish that remained within the starboard tank. Crewmember (A) entered the tank via the ladder access hatch in order to remove these fish remnants that had become impaled or stuck on the refrigeration system pipes. Carrying a yellow bucket Crewmember (A) descended the ladder and collected the fish and other material and then exited the tank via the ladder. Crewmember (A) had to wait on deck with the Skipper while the remaining water was pumped from the centre tank. When the remaining water had been discharged by the Skipper who was standing on the deck just forward of the main deck hatch, Crewmember (A) then entered the centre tank via the ladder access hatch (as indicated by the green arrow in Picture No.2). Carrying the yellow bucket, he descended the ladder to remove a number of fish that remained.

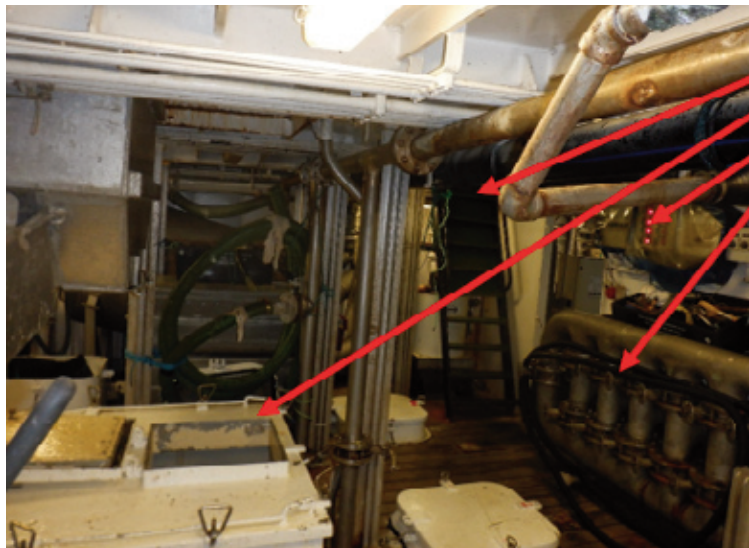
Picture No.3 RSW Tank Access and Valve Chest

- 3.3.3 Noticing a number of fish on the tank sump Crewmember (A) proceeded to the aft section of the tank passing below the internal tank boards to collect the remaining fish and material. Having collected three to five fish, Crewmember (A) then proceeded forward to exit via the tank ladder that is approximately five metres away from the tank aft bulkhead. While passing below the baffle boards in the centre of the tank Crewmember (A) placed the bucket on the tank floor. While maintaining contact with the bucket handle, he lowered his upper body and head towards the bucket, placing some weight on the handle for support while passing below the boards. Maintaining a hold on the bucket Crewmember(A) then stood upright. When standing upright Crewmember (A) immediately knew something was wrong and he was in trouble and noted “*feeling a burning sensation in his head*”. Crewmember (A) attempted to reach the ladder while calling for assistance from the Skipper on the deck above. At this point Crewmember (A) lost consciousness.

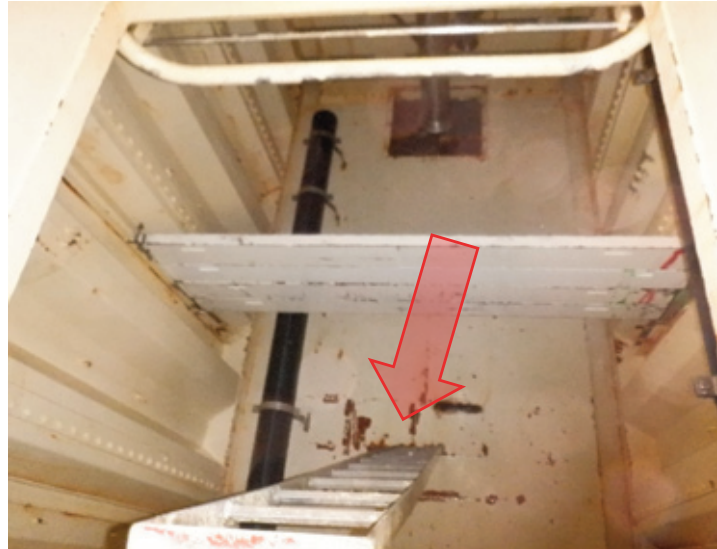
Picture No.4 Position of Crewmember (A)-Red arrow

- 3.3.4 The Skipper had gone forward to the refrigeration plant room/compartments to disengage the RSW pump via the controls panel (that is approximately 3.5 m from the tank access hatch). As the Skipper exited the refrigerated plant room, he heard a noise of something falling originating from the centre tank and he returned to the tank access hatch (see Picture No.3). Looking down the Skipper noted Crewmember (A) lying adjacent to the starboard side of the ladder (see Picture No.4). The Skipper then called for assistance from the other crewmembers, who joined him at the tank access hatch. Being aware there may be a lack of oxygen within the space and the possibility of gases, an attempt to ventilate the area was initiated. All three tank covers, and a number of deck hatches and vents were opened to increase the volume of air flowing below the shelter deck and into the tank space. Crewmember (C) advised against entering the tank due to the lack of appropriate Personal Protective Equipment (PPE) and

suitable recovery equipment but was overruled. Crewmembers (B) prepared to access the tank in order to assess the condition of Crewmember (A).

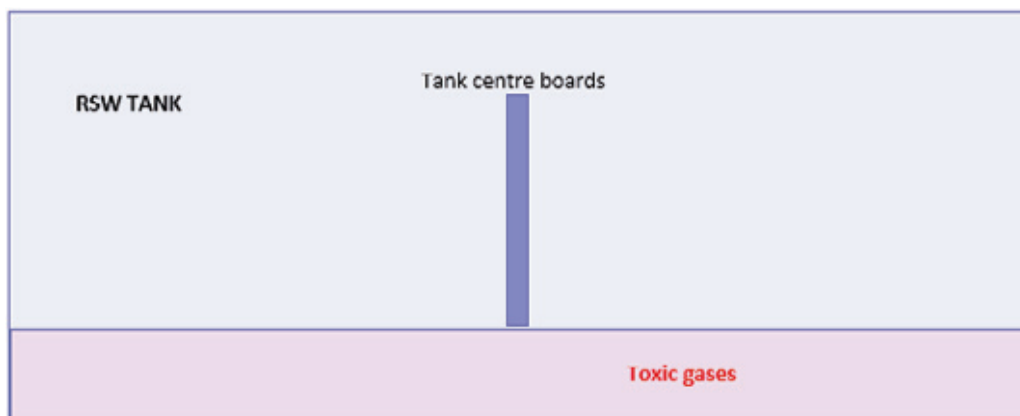
Figure 2 Gas Pooling Within a RSW Tank (for illustration only)

The remaining water was discharged overboard, trapping the released gases that were heavier than air, at lower levels within the tank.

Both Casualties were overcome by the toxic atmosphere when they lowered their heads into the toxic pool. The first Casualty was overcome while passing below the tank centre boards. The second Casualty was overcome while checking the condition of the first Casualty who was lying on the tank floor.

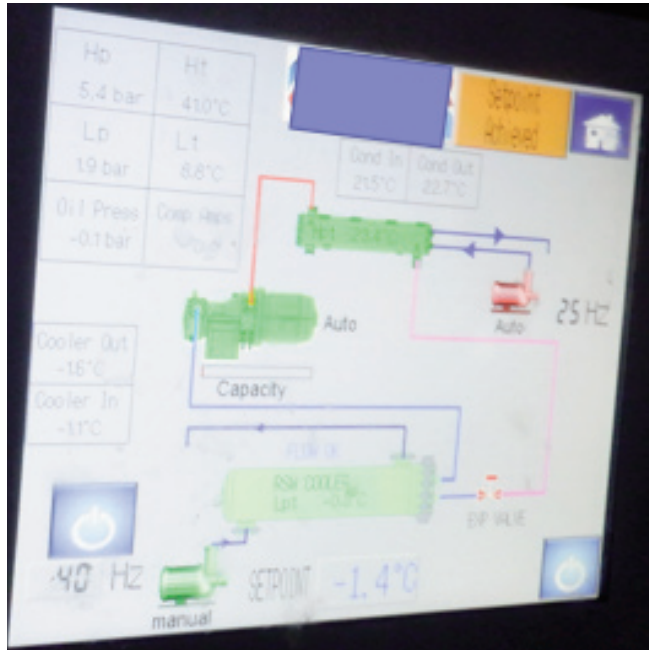
Picture No.5 RSW System Status Screen (during visit 6 November 2022)

The RSW refrigeration system was monitored and fitted with alarms to indicate system failure or operational alarm status state. On review of the refrigeration system data logger page on the status screen, no alarm status or fault was noted on the 31 October 2022 (see Appendix 7.9 - Additional Photographs Picture No.5 and No.6).

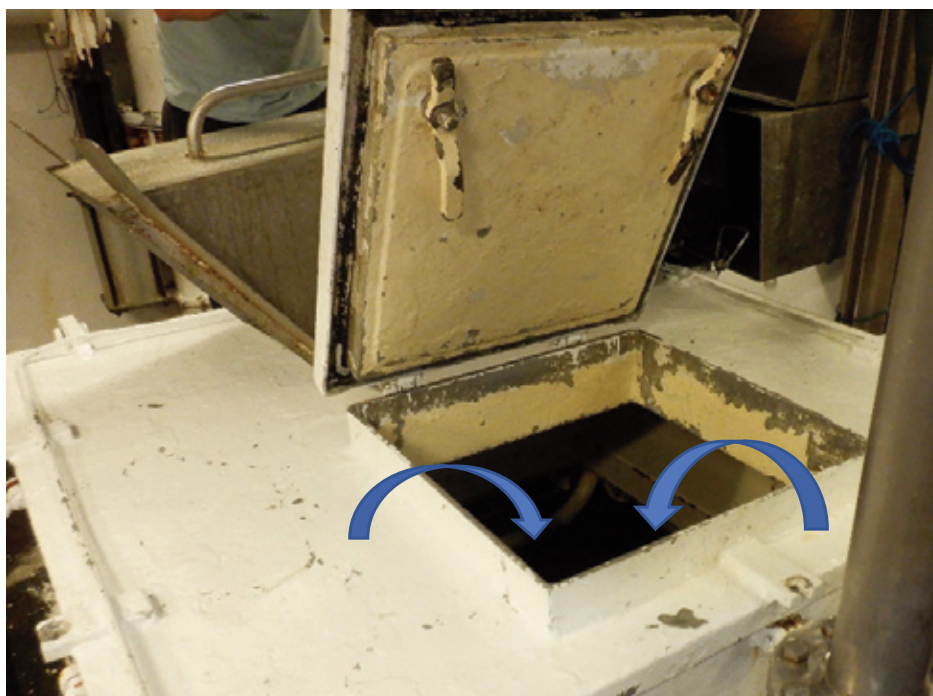
Picture No.8 Tank Ladder Access Hatch Opened as at Time of the Incident

The actions taken by the crewmembers including the opening of additional hatches and vents would have provided additional ventilation below decks (see Appendix 7.9 - Additional Photographs Picture No.8 and No.9).
