**MCIB**

**REPORT INTO A FATAL  
INCIDENT INVOLVING THE  
MFV ELLIE ADHAMH  
AT ROSSLARE EUROPORT  
19th MAY 2019**

**REPORT NO. MCIB/292  
(No.4 OF 2020)**

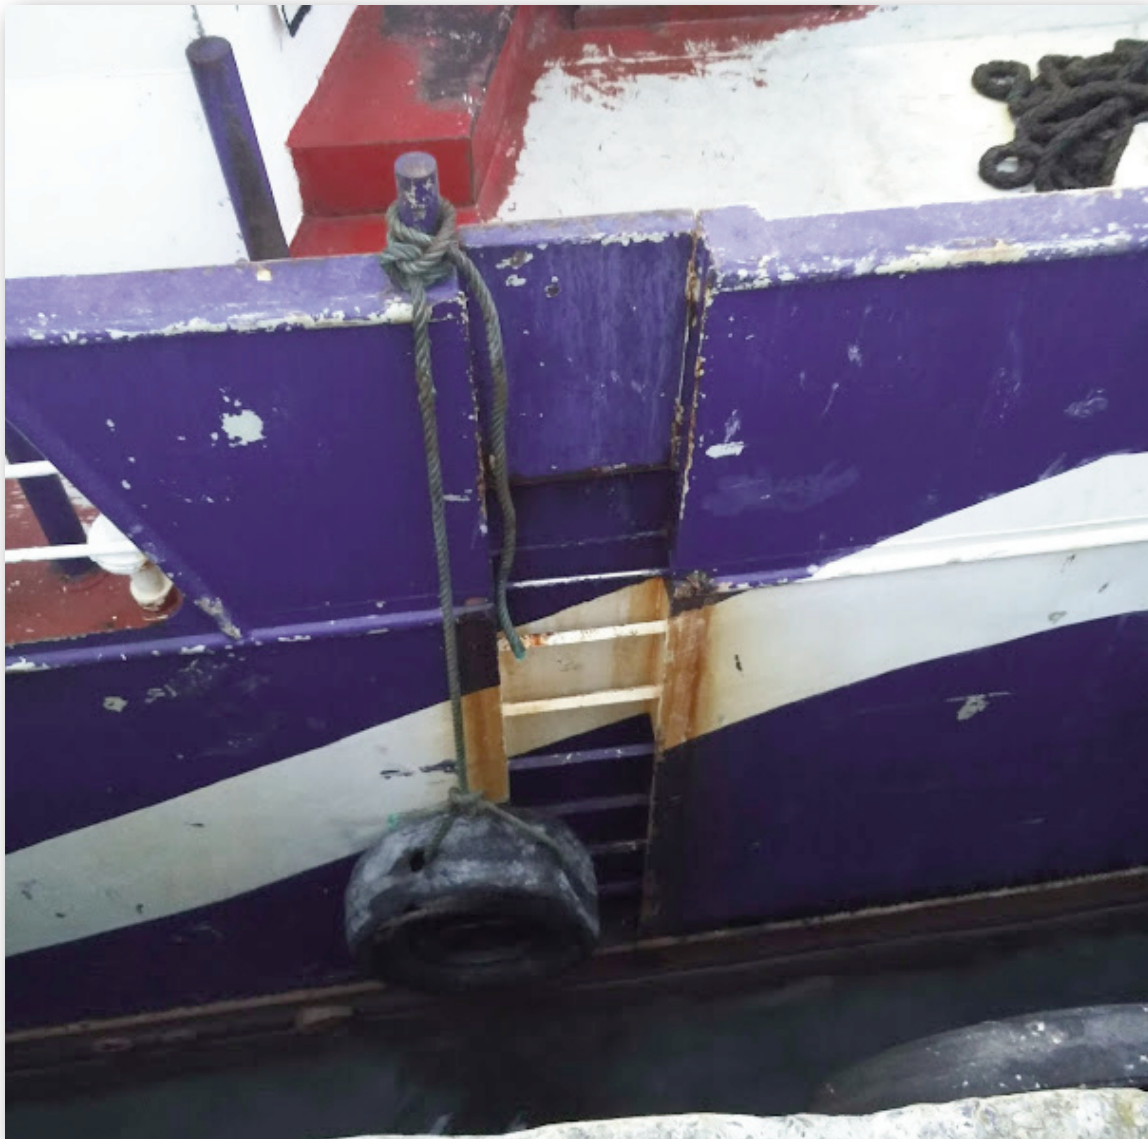
due for replacement. The *'MFV Ellie Adhamh'* has boarding ladders built in on both sides of the main hull (see Appendix 7.1 Photograph No. 3). No gangway or safety net were rigged and there is no clear designated access point between the *'MFV Ellie Adhamh'* and the quay wall (see Appendix 7.1 Photographs No. 4 and No. 5).

Photograph No. 3. Fixed boarding ladders built in on both sides of the hull of the 'MFV Ellie Adhamh'.

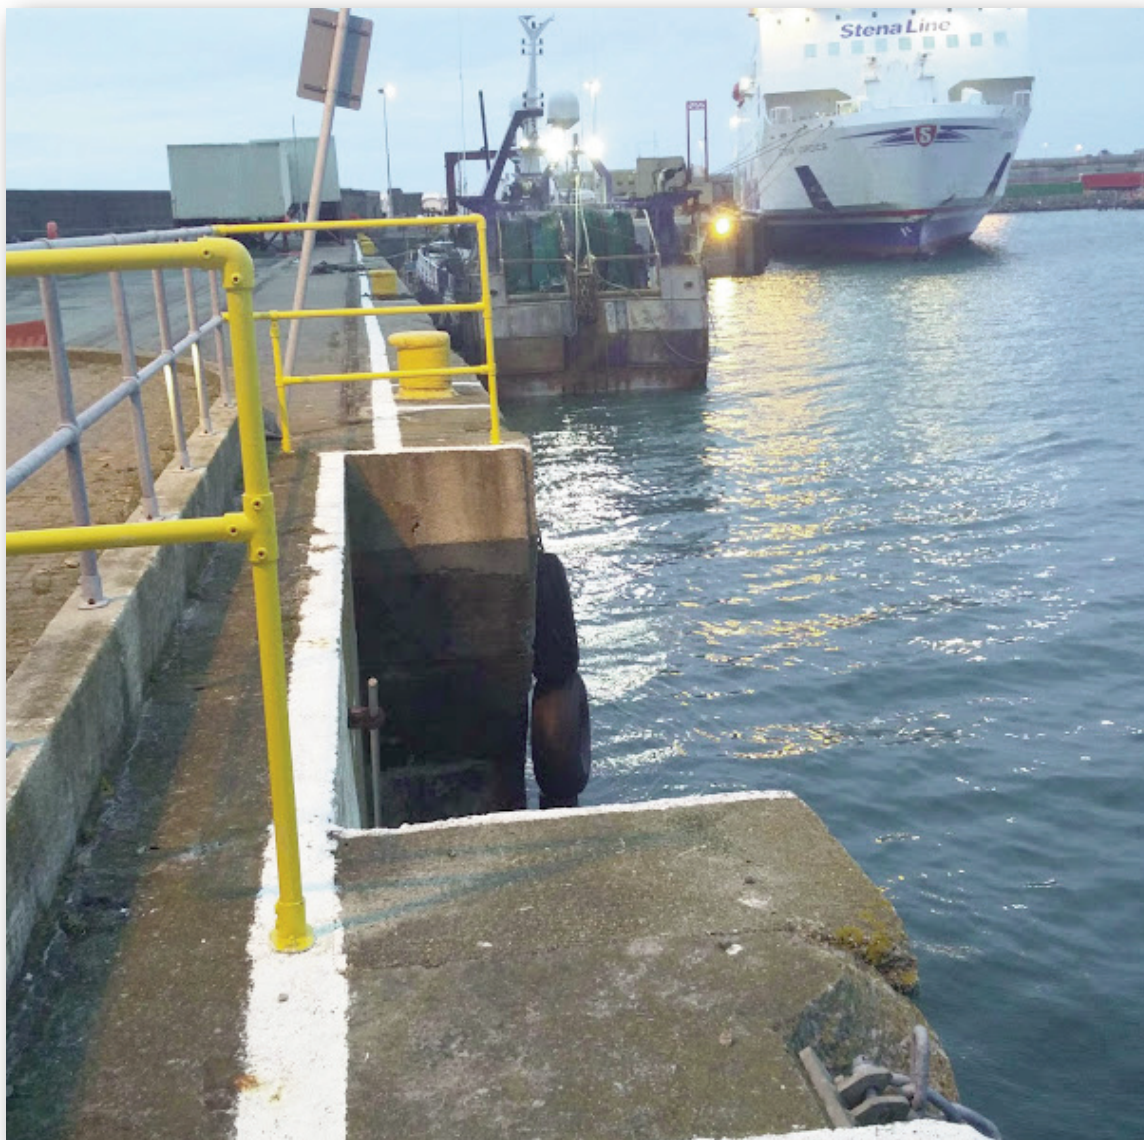
- 3.8 The Merchant Shipping (Safety of Fishing Vessels) (15-24 metres) Regulations 2007 require that a gangway or other suitable means providing an appropriate and safe means of boarding the vessel shall be available (Regulation 106).
- 3.9 The initial postmortem report supplied to the MCIB indicates death was caused by drowning, however, this verdict will be determined by the coroner. The toxicological analysis in the report indicated a very high level of ethanol in the Casualty's blood.

- 5.2 Safe means of access to the vessel at all states of tide was not evident.
- 5.3 No PFD was worn by the Casualty.
- 5.4 It is likely that there was considerable movement of the vessel due to manoeuvring of the *'MV Stena Nordica'* in close proximity to it. As the much larger vessel went astern into its berth it would have caused considerable water flow in the vicinity of the *'MFV Ellie Adhamh'*

Photograph No. 5. No gangway or safety net were rigged and there is no clear designated access point between the 'MFV Ellie Adhamh' and the quay wall.

- 6.2 It is recommended that the Minister for Transport, Tourism and Sport issue a Marine Notice reminding fishing vessel owners and skippers of the duty of care to provide safe means of access to vessels while in harbour.
