**REPORT OF AN INVESTIGATION  
INTO A MARINE CASUALTY  
INVOLVING THE FISHING VESSEL  
ARDENT  
EAST OF PORT ORIEL,  
CLOGHERHEAD, CO. LOUTH  
31 OCTOBER 2022**

**REPORT NO. MCIB/320  
(No.2 OF 2024)**

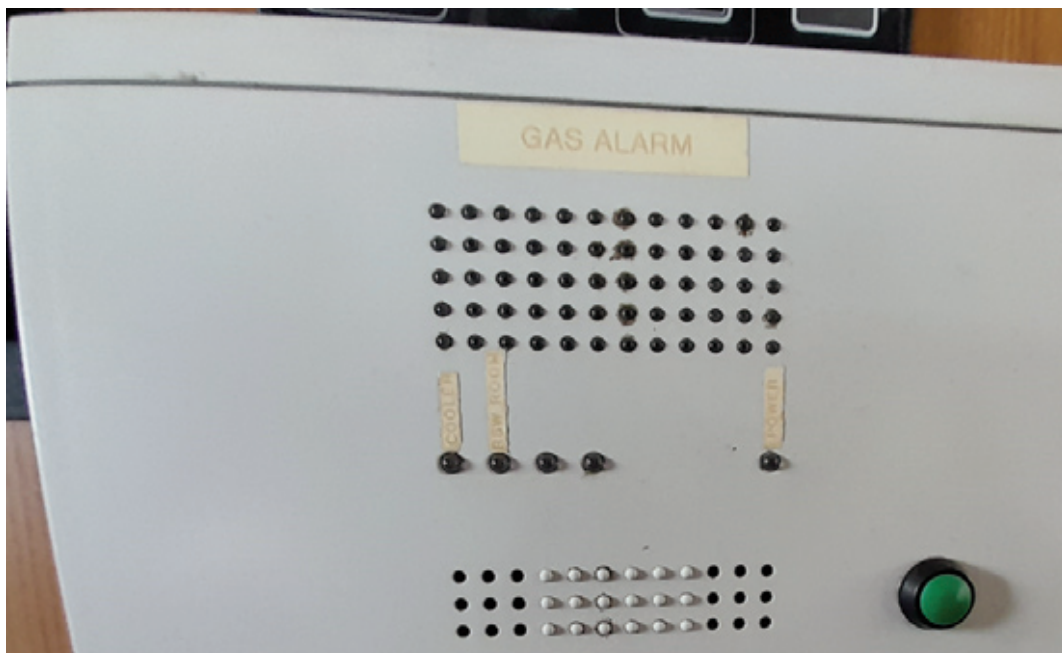
Picture No.7 Vessel Gas Alarm System

The vessel was fitted with a gas monitoring/alarm system with sensors fitted in the spaces containing refrigeration equipment. The alarm panel in the wheelhouse contained audio/visual alarms for the cooler and RSW room (see Appendix 7.9 - Additional Photographs Picture No.7).
